MERRIMACK RIVER BASIN
WENTWORTH, NEW HAMPSHIRE

**BAKER FLOODWATER RESERVOIR
SITE 11A
NH 00247**

**PHASE I INSPECTION REPORT
NATIONAL DAM INSPECTION PROGRAM**

JULY 1979

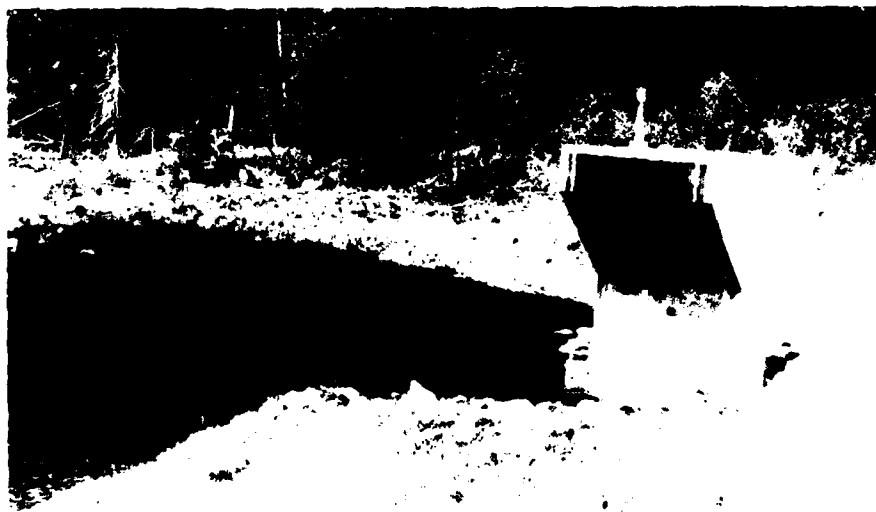
PHOTO NO. 6 - View of principal spillway and riser.

The principal spillway structure has a riprap-lined approach channel which parallels the upstream toe. The portion of the riprap which could be observed is shown in Photo No. 6 and is in good condition.

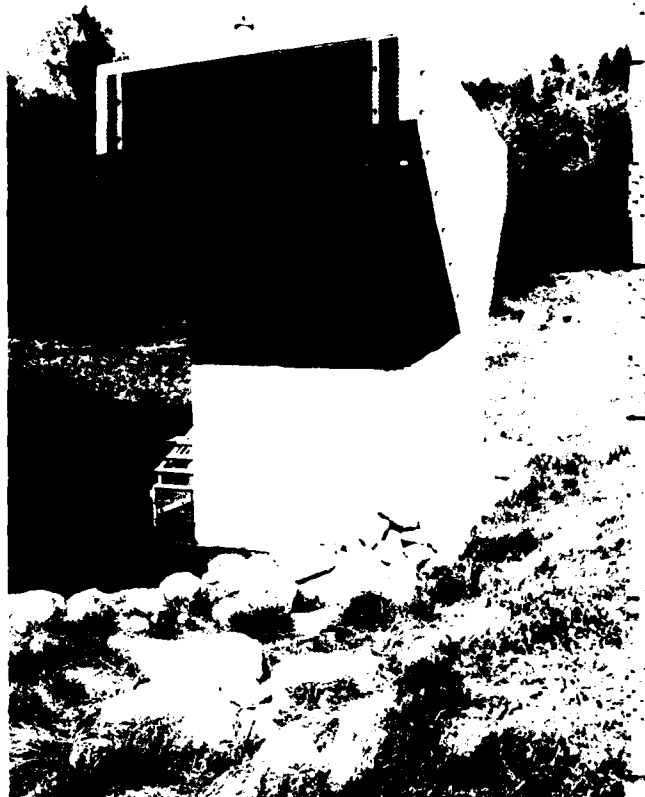
PHOTO NO. 7 - View of right side of principal spillway.

Field inspection revealed that the riser structure appeared to be in good condition except for rust and water staining, surface scaling, and random surface cracks, see Photos No. 7, 8, 9. The trash racks for the low and high stage intakes consist of standard shape angles and grating. Both trash racks assemblies are in good condition.

(1) Random surface cracks and scaling of concrete on the riser structure.

(c) Repair surface cracks and scaling on the riser structure.
